Detection and Repair to Uplift-Compromised Adhered Single-Ply Roof Membranes

By Marc N. Boulay

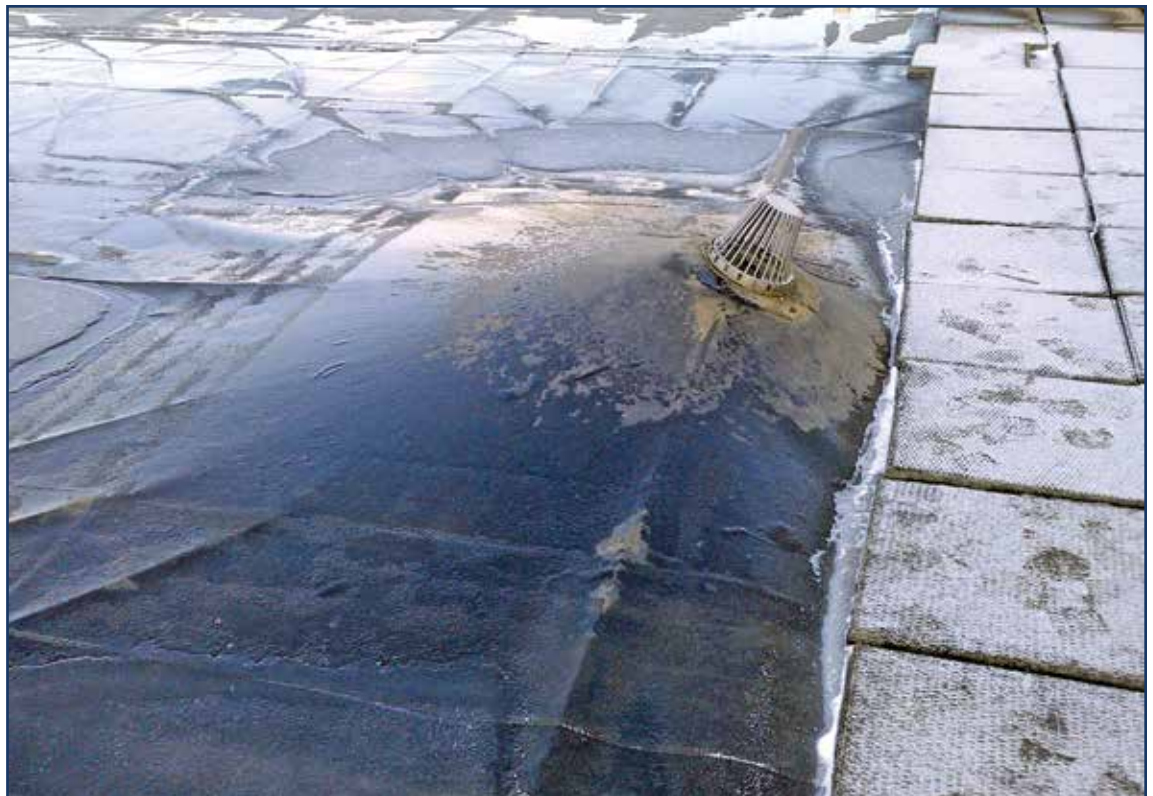
Figure 1 – The roof drain and cast-iron leader were dislodged by the uplift pressure on this roof system.

as the wind passes across the roof surface. Such uplift pressure can be sufficient to pull the membrane free of a properly adhered insulation stratum firmly attached to a structural, poured-in-place concrete roof deck. An example of such a condition is shown in *Figure 1*, where the roof drain and the cast-iron leader were dislodged by the uplift pressure (this on a roof system less than four years old and only in a select, middle area of that roof system—nowhere near a roof edge). Concrete pavers in the image were taken from another portion of the building and relocated beside the damaged area to temporarily stabilize the membrane until the permanent repairs could be performed.

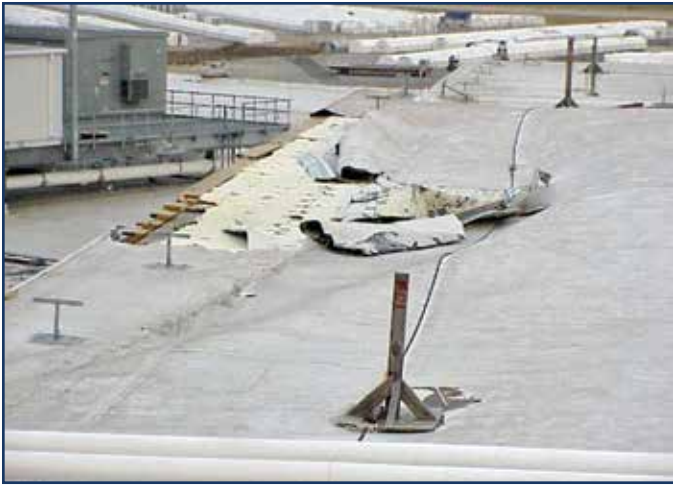
Figure 2 – Uplift damage to adhered PVC roof assembly.

geographic locations, and atop varying roof decks, from corrugated steel—where positive air pressure introduced through large wall openings was a notable contributing factor, to poured-in-place structural concrete—where positive pressure was a nonfactor. In these cases, a number of failures were noted as having commenced along the roof edge (as shown in the PVC roof system

failure in *Figure 2*) to select areas of the roofs that were nowhere near a roof edge and that had occurred at a relatively lower wind speed (45 to 65 mph) than we would have anticipated.

This PVC roof uplift damage occurred while the building was still under construction, without the building envelope being sealed, and with temporary coverings on walls and door openings. After occurrence of numerous uplift-compromised areas in the field of the roof and away from a roof edge, a series of investigations were conducted to closely examine all conditions and factors contributing to the uplift failure of this particular roof system, which over a number of years had increased to affect over 400,000 sq. ft.

An extensive series of test cuts were taken throughout the roof, which revealed the insulation facer firmly attached to the polyisocyanurate insulation foam core, turning the focus to the bonding adhesive. Test cuts in failed areas, as well as at still-adhered sections, were taken and shipped to a well-known testing lab for analysis. In this particular instance, the culprit was identified as substandard bonding adhesive, which was embrittled and unable to adequately restrain the membrane when exposed to moderate levels of uplift pressure.

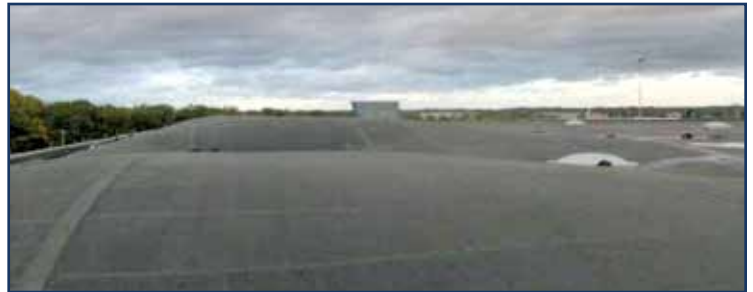
Disbonded single-ply membrane areas are apparent when the roof is noticeably elevated in what appears from a distance to resemble the top of a large balloon such as the EPDM and PVC roofs seen in *Figures 3* and *4*. Other failures are detected by the sound of flapping membrane and/or leakage at compromised membrane areas.

Figure 3 – Uplifted EPDM at compromised area.

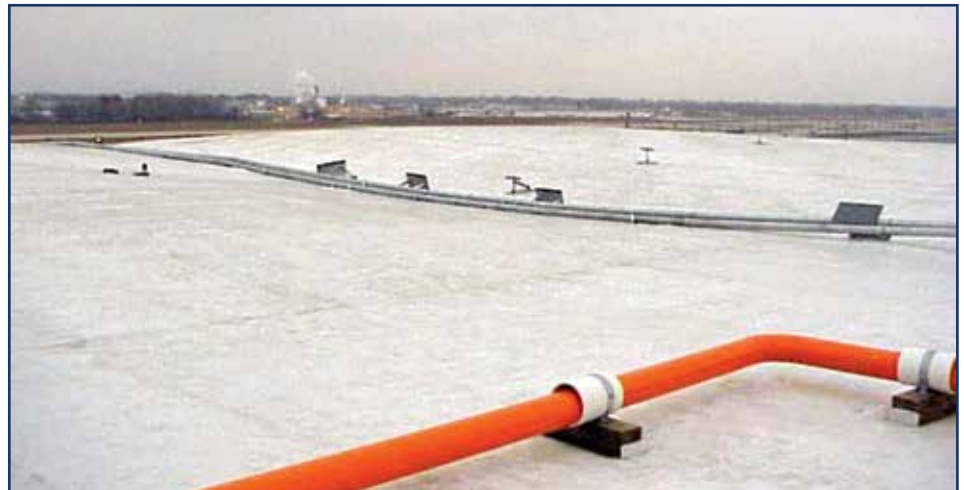
Figure 4 – Uplifted PVC roof at compromised area.

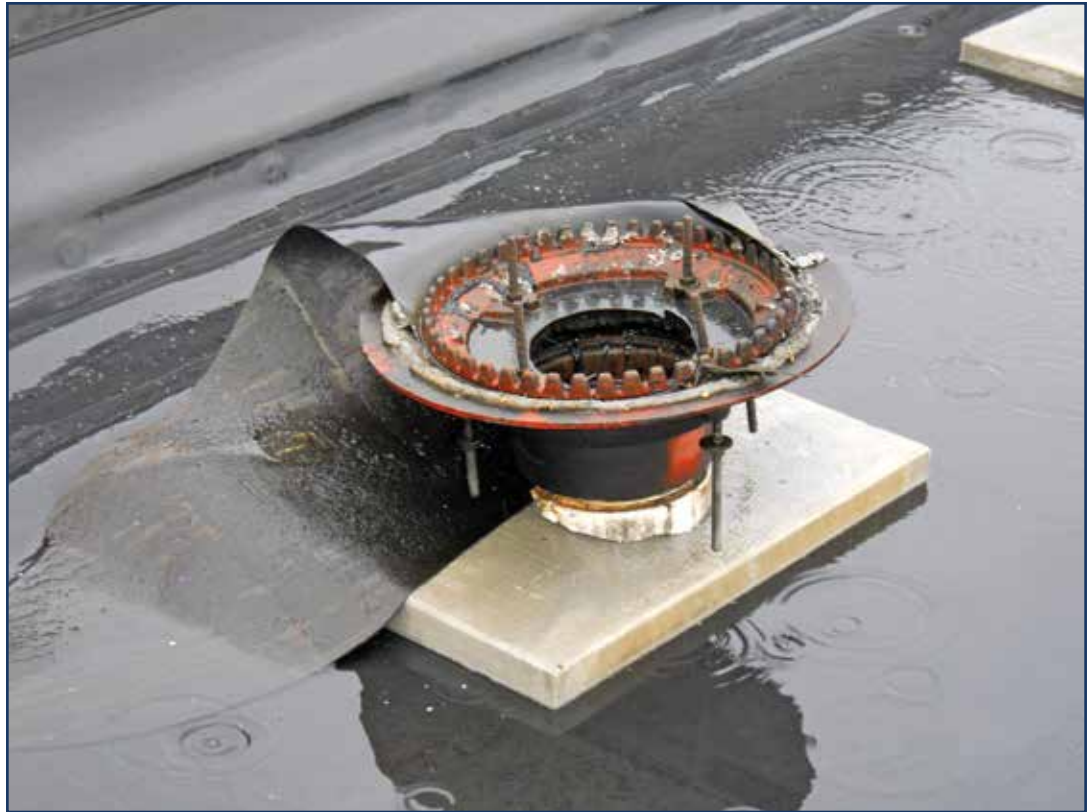
uplifted single-ply membranes can include roof drains, as can be seen in *Figure 5*. In this example of a dislodged roof drain on an EPDM roof system atop a corrugated steel roof deck assembly, the PVC piping fractured and the membrane tore free of the building, resulting in widespread leakage and interruption to the building operation.

Figure 5 – Dislodged roof drain on uplifted EPDM area.

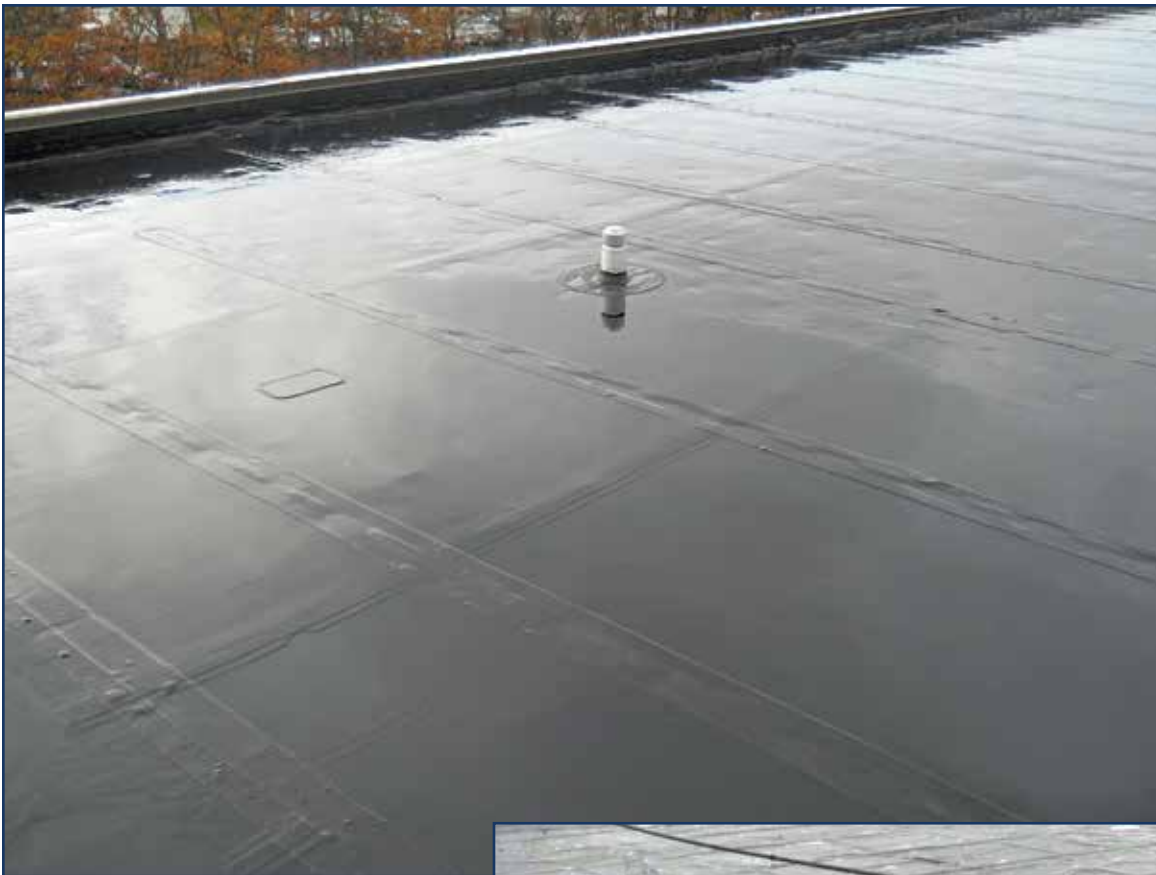
Figure 6 – Disbonded EPDM membrane area in foreground; adjacent area in background is still bonded.

On such assemblies, disbonded areas are easily detected during inspection. An example of a disbonded EPDM area with a smooth surface that peeled away from the

insulation facer is shown in the foreground of *Figure 6*, while the adhered plates of the solidly adhered membrane area are shown in the background of the same image.

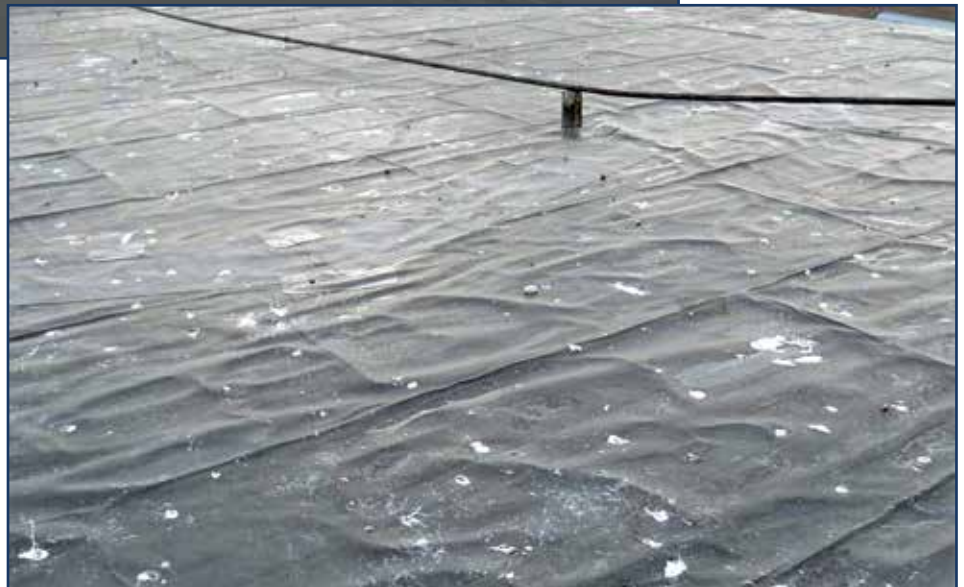
Figure 7 – Disbonded EPDM membrane with iso facer adhered to underside, pulled free of the foam core.

Uplift damaged or disbonded EPDM membrane areas where the insulation facer pulled free of the foam core and remains adhered to the backside of the disbonded membrane have a very distorted surface appearance, as seen in *Figure 7*. Once disbonded areas of an adhered single-ply membrane are identified, remediation work should commence in a timely fashion to halt the size of uplift-damaged areas.

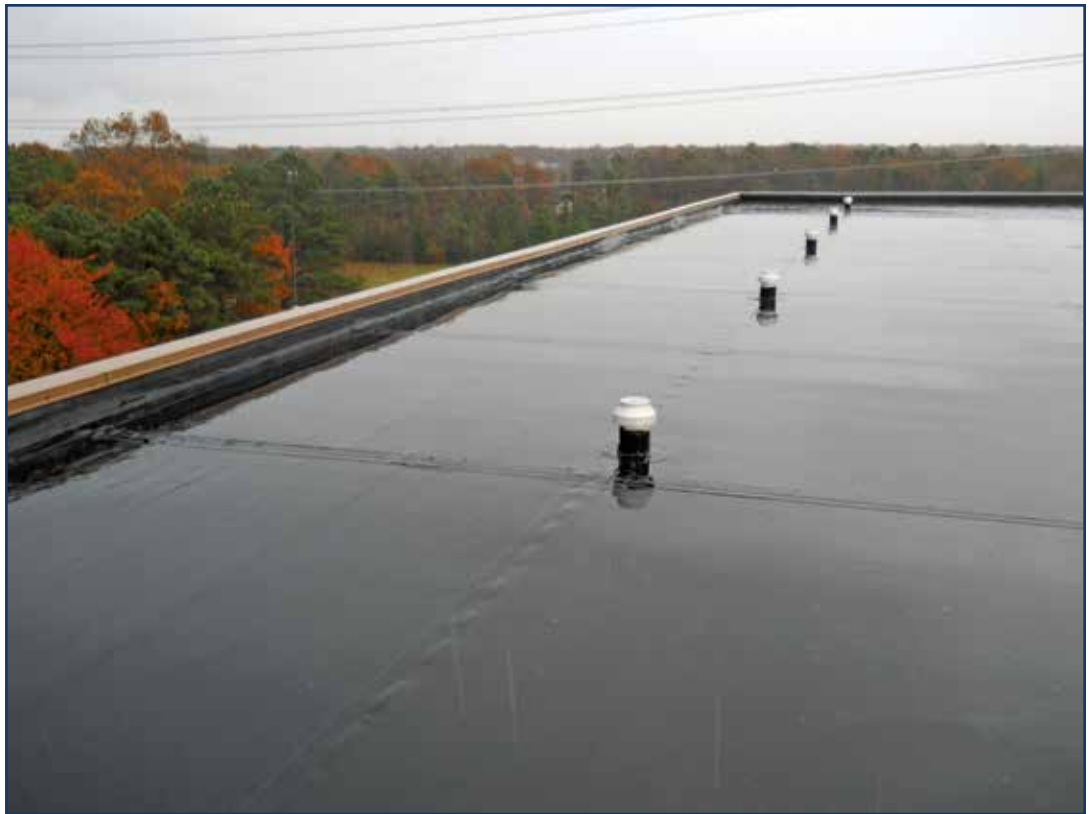
Figure 8 – One-way air vents installed along edge of disbonded EPDM membrane area.

In such an instance, the disbonded roof area should be examined to determine the feasibility of repairing the areas and converting the system into a hybrid mechanically attached assembly with a series of batten strips and one-way air vents. Proceeding with a repair project involves installing the battens around the perimeter of the uplifted areas, around roof drains, and at set intervals through the body of the uplifted areas, positioned perpendicular to the steel deck direction. Once battens are installed atop an EPDM membrane, the areas should be properly cleaned with a weathered EPDM cleaner, then primed and covered over with a semi-cured EPDM/butyl tape membrane. New one-way air vents should then be installed along the roof area perimeter at intervals of 20 to 30 ft. and about the body of a larger uplifted area, with the number and position to be determined by the field conditions and the size of the area involved. The air vents act as purge valves, minimizing the uplift pressures on the membrane by providing a means of egress for positive air pressure on buildings with large wall openings and on buildings with a mostly enclosed envelope, allowing negative air pressure to act as a downward force on the membrane.

Disbonded single-ply roof areas that were repaired using this combined method of battens and one-way air vents have been in successful service for upwards of ten years on various assemblies. An example of one of the roofs repaired in this manner is on a building on Long Island, NY, shown in Figure 8. Note that this hybrid repaired area is positioned nearly 50 ft. high and with open exposure due to the surrounding low terrain. It has, over the years, successfully weathered a series of subsequent high-wind events that resulted in uplift damage to other, lower portions of this same building without any issues on the repaired area.

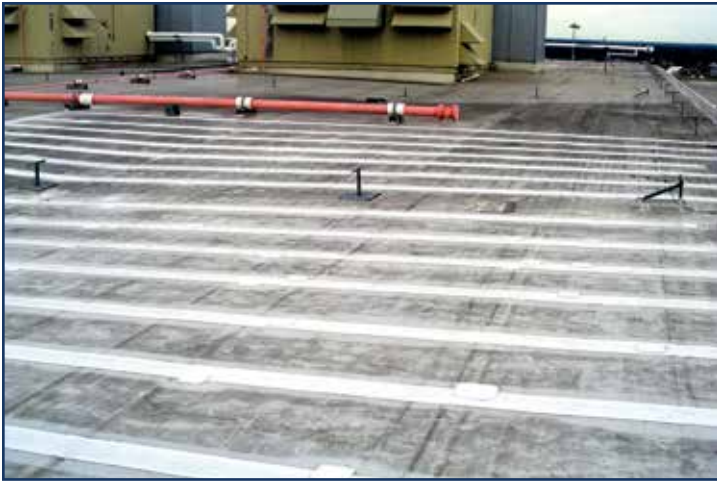
Figure 9 – Tightly clustered batten securement of an uplifted, fiberglass-reinforced PVC membrane area.

placement at a tighter spacing than if the sheet is a polyester scrim membrane, due to the fact that fiberglass-reinforced PVC membranes cannot withstand routine flexure without compromise.

An example of a tight (3-ft.) spacing of polymer battens on an uplifted, compromised area of a fiberglass, scrim-reinforced PVC membrane is shown in *Figure 9*.

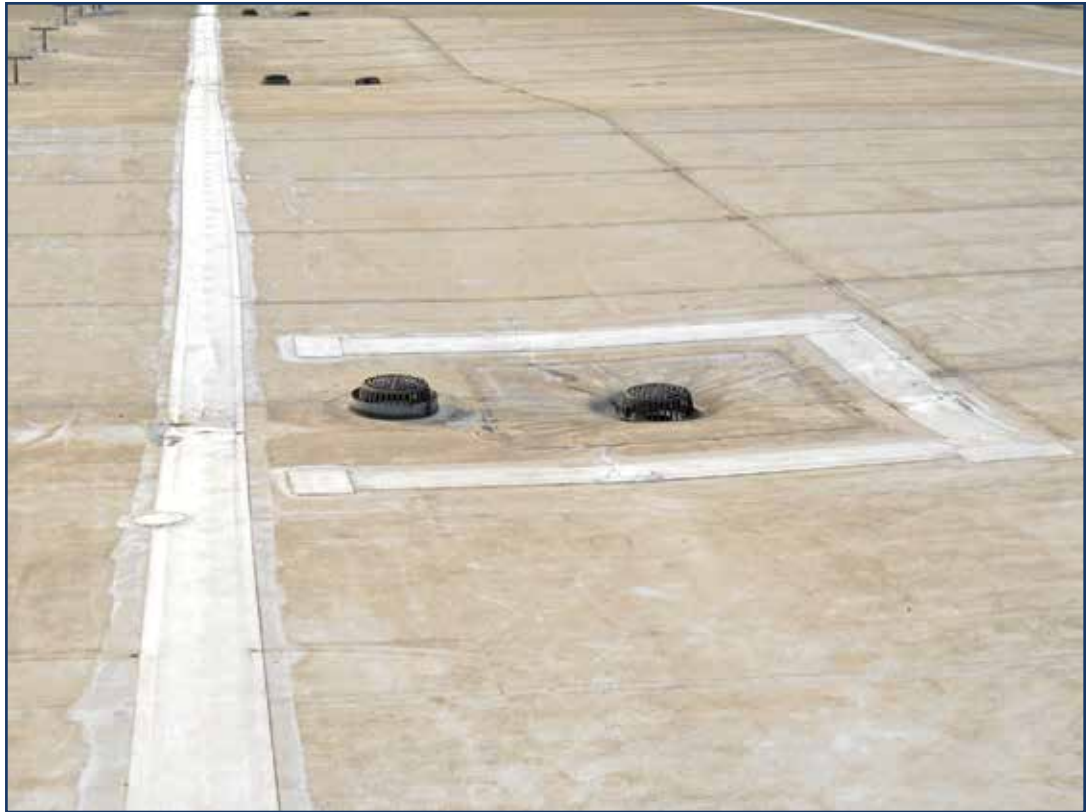
Figure 10 – Battens around roof drain on uplifted area.

Such extensive batten work is costly, and it may be less expensive to simply replace the membrane area with a polyester scrim PVC membrane for a permanent repair. Temporary repair could have employed battens around the roof drains and at wider intervals, with one-way air vents installed. An example of such a repair is shown in *Figure 10*, with that particular area awaiting installation of the one-way air vents.
